PORT EVERGLADES MANGROVE WETLAND ASSESSMENT

Mangrove Wetland Assessment Report
February 22, 2008

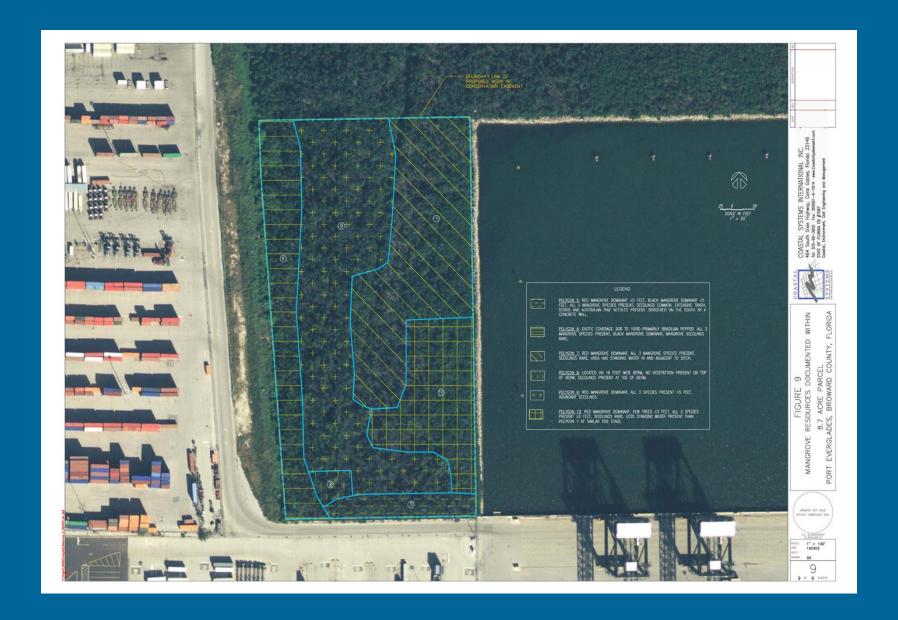
- 50 GPS points obtained in 8.7 acre parcel
- 10 transects running east/west w/5 points per transect
- Data collected at each point
  - Ø Species of mangrove
  - Ø Trees>5'

§ Diameter at Breast
    Height (DBH)
    § Tree height
  - Ø Trees <5' number of trees
  - Occurrence of seedlings (rare, common, abundant)
  - Ø Percent cover of exotics
  - Ø Wildlife present, if any
  - Ø Hydrologic conditions

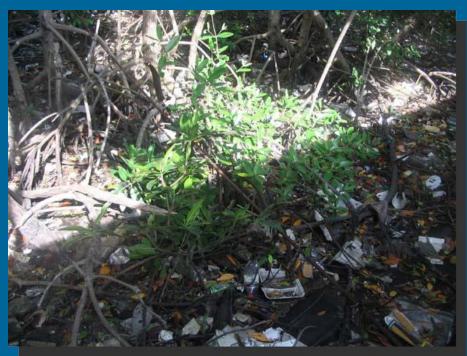
Photo #24

Characterization	Large amounts of trash and debris
Mean DBH	2.4 inches
Mean Tree Height	16 feet
<ul> <li>Mean number of trees &lt;5 feet</li> </ul>	2
Seedlings	abundant
UMAM Score	0.57
Acreage	0.36 acre
• Debits	0.21 functional unit

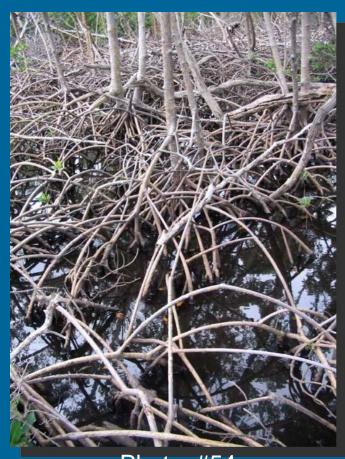
Photo #54

Characterization	Mature mangrove forest with predominately large trees and regular hydrologic exchange
Mean DBH	3.4 inches
Mean Tree Height	19 feet
Mean number of trees <5 feet	1.2
Seedlings	Rare
UMAM Score	0.73
Acreage	2.44 acres
• Debits	1.78 functional units

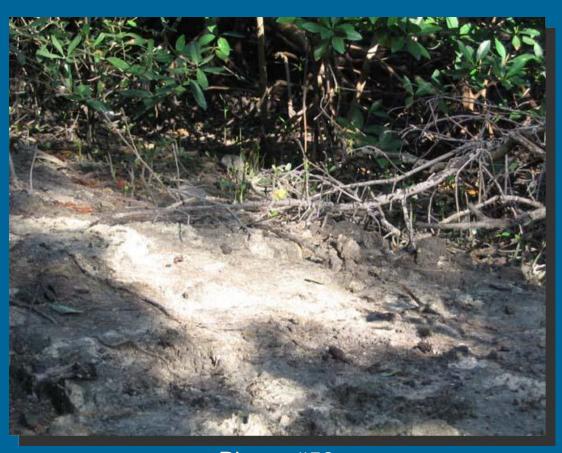
Photo #59

•	Characterization	.Highest ground elevation
•	Mean DBH	.N/A
•	Mean Tree Height	.N/A
•	Mean number of trees <5 feet	.N/A
•	Seedlings	Abundant at toe of berm None on top of berm
•	UMAM Score	0.20
•	Acreage	.0.12 acre
•	Debits	0.02 functional unit

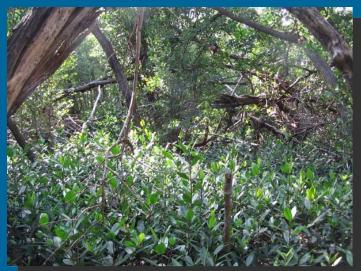
Photo #61

Characterization	Small trees, abundant seedlings and restricted hydrology
Mean DBH	2.2 inches
Mean Tree Height	17 feet
<ul> <li>Mean number of trees &lt;5 feet</li> </ul>	7.9
Seedlings	Abundant
UMAM Score	0.63
Acreage	3.15 acres
• Debits	1.99 functional units

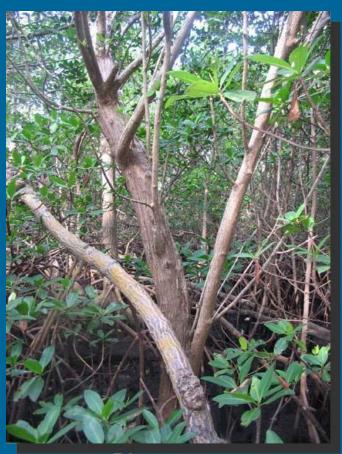
Photo #91

Characterization	Fairly mature mangrove forest with regular hydrologic exchange
Mean DBH	2.5 inches
Mean Tree Height	17 feet
<ul> <li>Mean number of trees &lt;5 feet</li> </ul>	2.9
Seedlings	Rare
UMAM Score	0.70
Acreage	1.27 acres
• Debits	0.89 functional unit
